Dynamic characteristics and seismic behavior of prefabricated steel stairs in a full-scale five-story building shake table test program

Xiang Wang¹, Rodrigo Astroza^{1,2}, Tara C. Hutchinson^{1,*},†, Joel P. Conte¹ and José I. Restrepo¹

SUMMARY

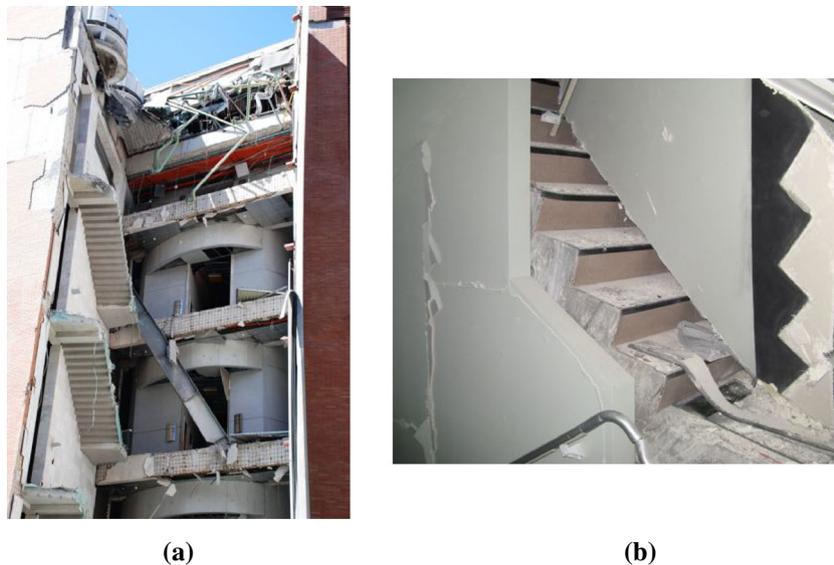
Figure 1. Stair damage in prior earthquakes: (a) crumbled exterior reinforced concrete stairs in the 2010 Maule earthquake and (b) damaged interior precast concrete stairs in the 2011 Christchurch earthquake.

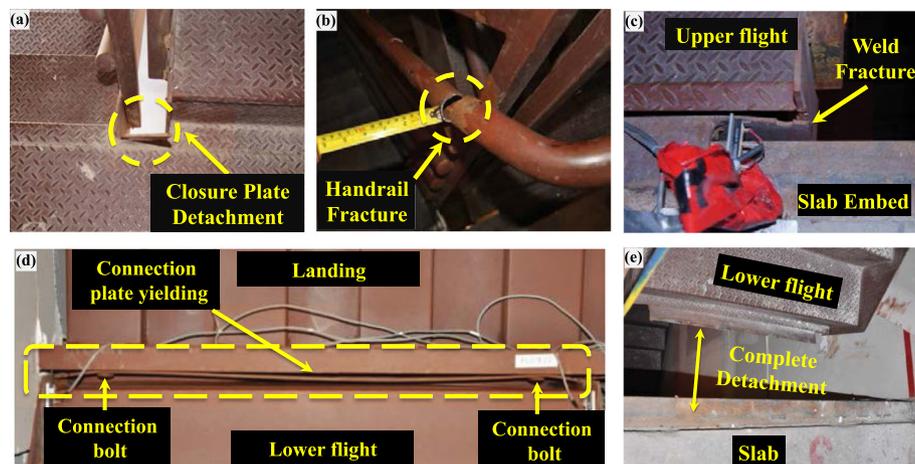
Figure 9. Examples of observed stair damage: (a) closure plate detachment (DS-1; photograph taken at the landing between level 1 and 2 after test FB-4), (b) handrail fracture (DS-1; photograph taken at level 3 after test FB-5), (c) upper flight connection angle weld fracture (DS-3; photograph taken at level 3 following test FB-4), (d) plastic yielding of the connection plate between the landing and lower flight (DS-2; photograph showing the bottom view of the landing at level 2 following test FB-5), and (e) lower flight detachment and complete loss of vertical support (DS-3; photograph taken at level 3 after test FB-6).

the partition walls. As shown in Figure 9, five common types of damage mechanisms were observed during the tests. These are categorized into three distinct damage states (DSs) according to their implications on stair functionality and repair actions. The definitions of the damage states and the physical description of the observed damage are summarized in Table IV, and the repair actions implemented in these tests for the different damage mechanisms are illustrated in Figure 10. It is noted that, while no repair action was taken for minor and moderate damage during these tests, severe damage to the stairs was repaired immediately to restore safe access to the test building and to allow the execution of subsequent tests.

FB-5:DEN67 – Damage to the stairs was distributed at various locations in the form of closure plate detachment (DS-1), handrail fracture (DS-1) (Figure 9(b)), connection plate yielding (DS-2) (Figure 9(d)), and connection weld fracture (DS-3). Severe damage that required immediate repair included (i) the lower flight connection angle stitch weld fracture (note that the lower flight did not slide off of its vertical support at the slab embeds, however it was completely detached) at level 3 (DS-3) and (ii) the upper flight connection angle vertical fillet weld fractures (DS-3) at levels 1, 3, and 4. Repair of the lower flight connection angle stitch weld fracture was conducted by re-welding of the lower flight connection angle to the slab embed (R-III), and the three cases of the upper flight connection angle vertical weld fracture were repaired by R-II. In addition, plastic yielding occurred at the connection plate (DS-2) between the landing and the lower flight at level 2 as well as at the washer plates (DS-2) of the lower flight to landing connection at level 1.

FB-6:DEN100 – The lower flights at levels 3 and 4 completely detached and slid off of their vertical support at the slab embeds (DS-3) because of complete weld failure (Figure 9(e)). Repair of the detached flights involved use of a pulley to re-position the flights in place and subsequent re-welding of the flights to the slab embeds (R-III). In addition, plastic yielding of the connection plate (DS-2) between the landing and the lower flight at level 1 was detected, and the washer plates of the lower flight to landing connection at level 1 suffered continued plastic deformation (DS-2).

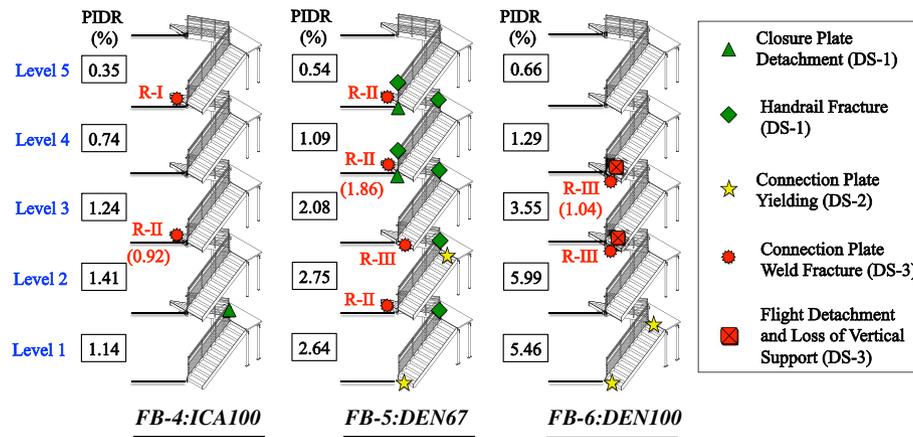
Figure 11. Stair damage progression during the last three fixed-base (FB) tests (notes: damage types are differentiated by color and marker shape, that is, red for DS-3, yellow for DS-2, and green for DS-1; boxed values represent peak interstory drift ratios (PIDRs) during the specified seismic tests and are shown in black, and red values in parenthesis represent the actual interstory drift ratios (IDRs) at damage instance).

During all seismic tests, eight instances of severe damage were detected at all levels except at level 5. Severe damage to the stairs at each level initiated consistently in the form of upper flight connection angle vertical fillet weld fracture, with associated PIDRs of 2.64% at level 1 (test FB-5), 1.41 at level 2 (test FB-4), 2.08% at level 3 (test FB-5), and 0.74% at level 4 (test FB-4). Notably, even prior to attainment of the building design target PIDR, safe egress from the building was compromised during test FB-4 as a result of the two occurrences of upper flight connection angle vertical fillet weld fracture. The associated PIDRs, which caused this severe damage (0.74% and 1.41%), were much lower than the design performance target (PIDR of 2.5%). During the last two FB tests, severe damage to the

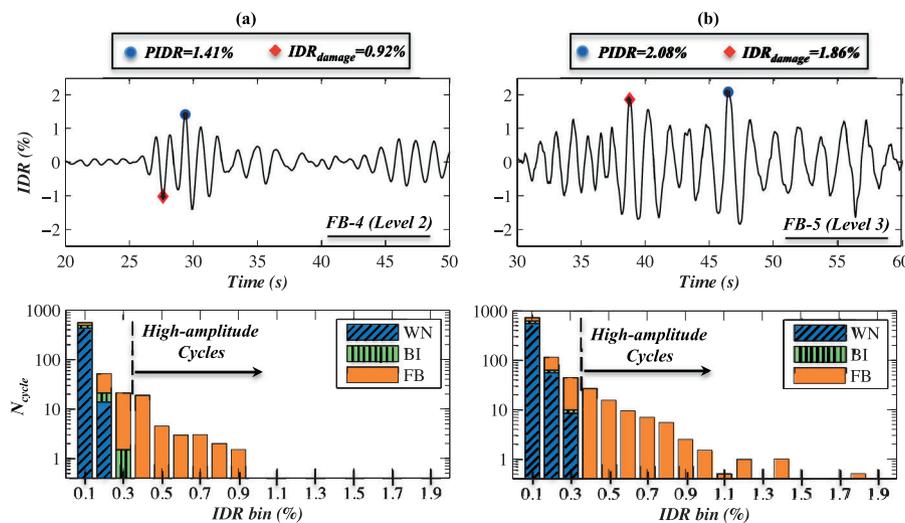
Figure 12. Interstory drift response and the accumulated interstory drift ratio (IDR) cycle distribution for the two instances of upper flight connection angle vertical weld fracture: (a) FB-4-ICA100 and (b) FB-5:DEN67. (PIDR), peak interstory drift ratio; (WN), white noise tests; (BI), base-isolated seismic tests; (FB), fixed-base seismic tests.

As shown in Figure 12, the majority of low-amplitude cycles (0.1–0.3% bins) occurred during the WN and base-isolated tests, while high-amplitude cycles (0.4%-and-higher bins) were exclusively attributed to the fixed-base tests. It is also shown in Figure 12 that the stair at level 3 experienced 66 high-amplitude IDR cycles prior to the weld fracture, as compared with 33.5 cycles for the same type of damage, which occurred at level 2. The two damage instances may not provide adequate information on the low-cycle fatigue behavior of the welds; however, these observations do not warrant a clear trend of loading histories on the weld fracture, because the stair that was damaged at a higher IDR value (1.86%) underwent twice as many high-amplitude cycles as the one damaged at a lower IDR value (0.92%).
