5 Common Issues with *Existing Expansion Joint Covers*

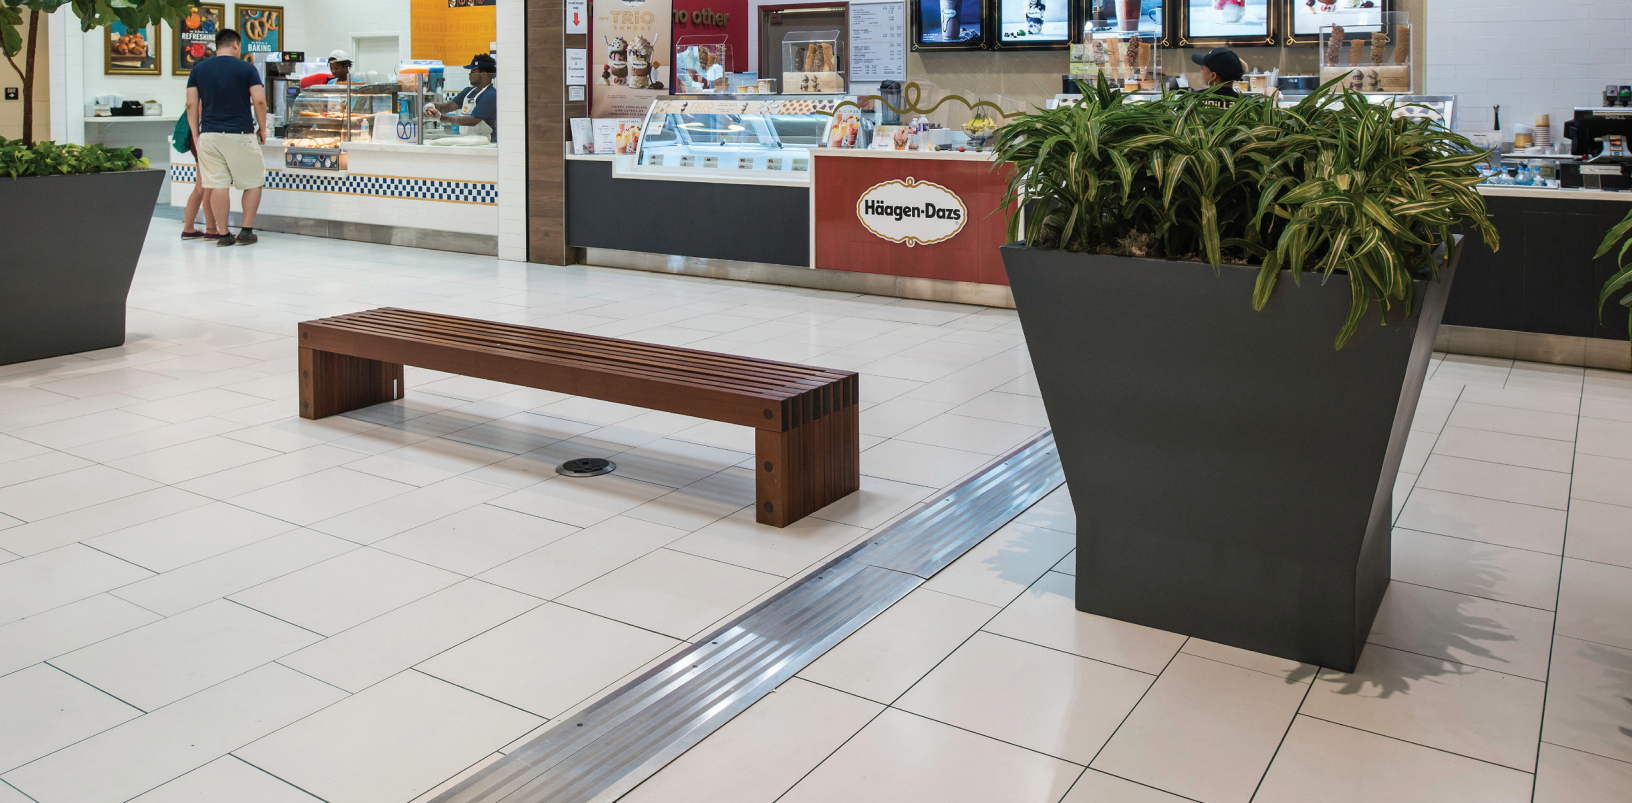
Warping

Due to:

- Incorrect cover was specified (standard vs. heavy duty)
- Point load considerations were exceeded by cranes, carts, cars, cleaning equipment, etc.

Cracked Finishes

- Improper installation of cover assembly or adjacent finishes
- Building movement was exceeded
- Loading capabilities were exceeded

Tripping Hazard

- Improper installation
- Building movement was exceeded
- Damaged cover
- Building settlement

Excessive Noise

- Damage or absence of internal gasket
- Improper installation
- Loosening screws
- Warping

Leaking Water

- Absence of moisture barrier
- Poor blockout conditions
- Excessive water loads
- Improper installation
- Bad splice
