Seismically-Resilient Stair Systems for Buildings

Cameron J. Black, Ph.D. P.E., Associate
Ian D. Aiken, Ph.D. P.E., Principal
Seismic Isolation Engineering, Inc.
Berkeley, CA

Kevin W. Smith, P.E.
Robert J. Belvin, P.E.
Anthony J. Peachey
Construction Specialties, Inc.
Muncy, PA

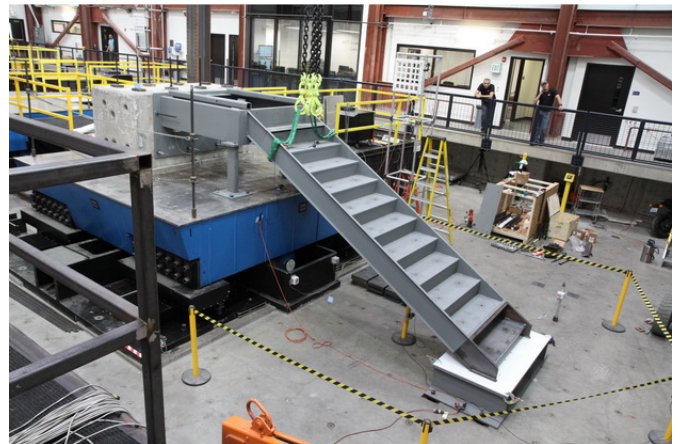
Figure 2: Testing Setup at the University of Nevada, Reno

The test setup comprised a stiff upper landing attached to a reaction block on the shake table with the lower landing fixed to the laboratory strong floor. In this configuration, movement of the table resulted in relative movement between the two landings simulating interstory drift. The stair specimen itself was designed so that each end could be replaced allowing multiple configurations and combinations of top and bottom connections to be tested using the same central portion of the stairs. To achieve this, the top and bottom stair and their connection portions were bolted to the center nine-step section comprising the stringers, risers and treads. The overall setup and the stair specimen with removable ends is shown in Figure 2. Many different configurations were tested and six are described in the results summary of Section 3.4.

The stairs were tested with steel plates attached to the treads to simulate 100 psf live load, as per ASCE 7-10. In addition, some configurations were tested with 50 psf live load or no live load to investigate the effect of the load on the response.

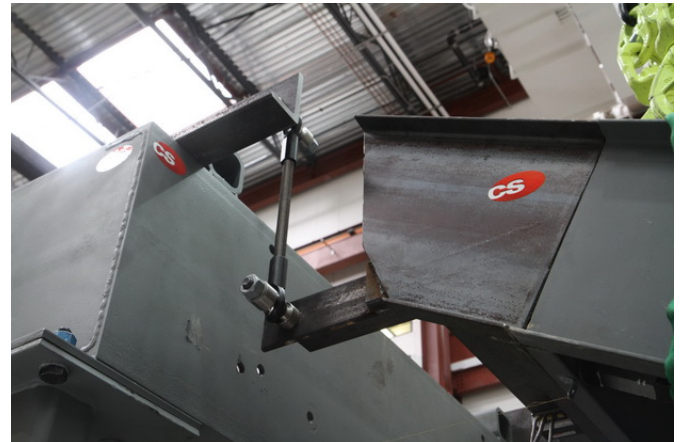
Figure 5: Hanger Assembly

In this configuration, rod end bearings, or heim joints, were used on either end of a threaded rod to suspend the stairs from the top landing (Figure 5). These hanger assemblies were supported by two cantilevers extending from the landing to provide clearance for the stairs to move towards the landing. The bottom of the stairs rested on a high-density polyethylene (HDPE) sliding surface with spring assemblies installed to provide restoring force in the transverse direction (Figure 6). This configuration was designed to have unrestricted movement at the top landing with the bottom connection allowing rotation and movement with a transverse restoring force.

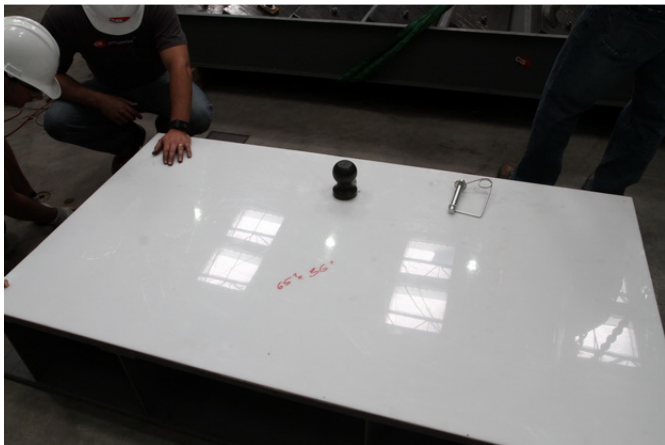
Figure 8: Pin at Base

In this configuration, the top connection comprised the hanger assemblies of 3.4a while the bottom was supported on a physical pin consisting of a trailer hitch receiver attached to the underside of the stair and a hitch ball attached to the bottom landing (Figure 8). The motivation to test this configuration was to investigate the response with translation completely restrained at the base.

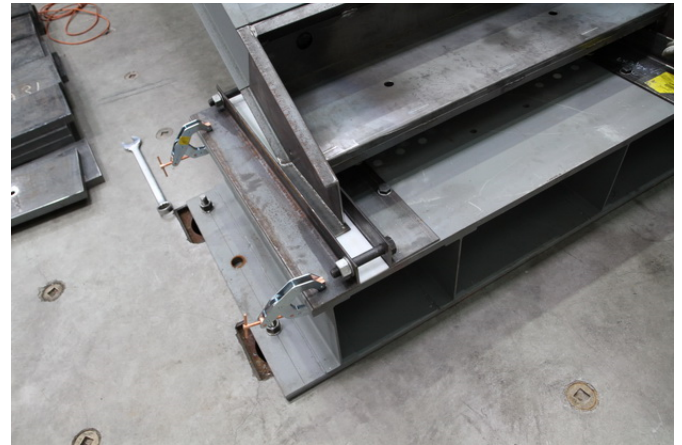
Figure 12: Sliding Base with Guides

accommodate rotation. A schematic view and a photo of the slide track are given in Figures 10 and 11, respectively. Figure 12 shows the lower base guides.

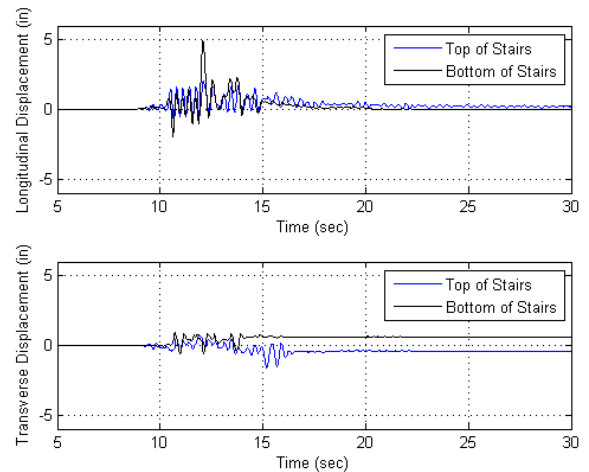
Figure 13: Relative Displacement History Between Landing and Stairs (MCE; Slide Track–Base Guides)

The response of the slide track-base guide configuration showed that this system was also effective in accommodating drift. It was observed that the oversized slide track and base guides allowed considerable rotation which over the length of the stairs accommodated nearly all of the imposed transverse drift, as seen in Figure 13.

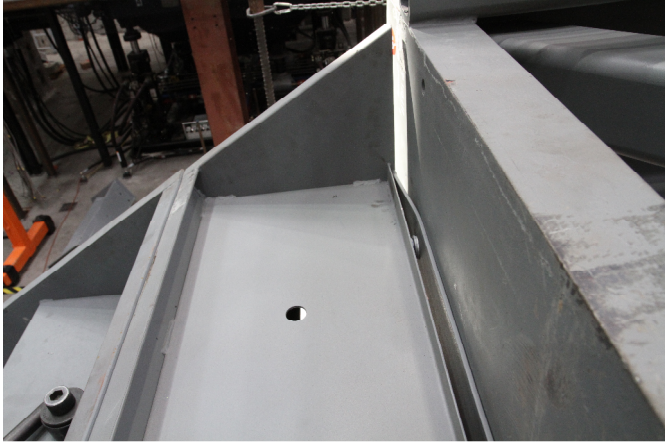
Figure 14: Yielded Mounting Plate

This configuration was first tested without any additional mass. After completion of the MCE motion the stairs were inspected and it was found that the mounting plate at the top landing had yielded and was permanently deformed (Figure 14). A similar result was reported in Higgins (2009) and by Wang et al. (2015) and shown in Figure 1(d) of this paper. From the data it can be seen that the yielding and permanent deformation at the top of the stairs occurred during the pulse at about 13 seconds (Figure 15). This configuration resulted in nearly 8 in. of displacement at the base, compared to 4 or 5

In order to continue testing with the additional live load, the stairs were removed, the mounting plate was straightened and additional gussets and welds were added to strengthen the connection. With the strengthened landing connection, the stairs were loaded with the full live load and re-tested. All tests completed successfully except the MCE motion which fractured the weld between the mounting plate and the stringer, despite the additional strengthening.

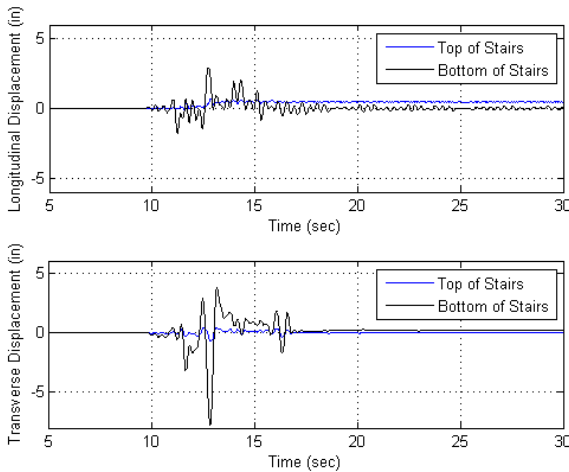
Figure 15: Relative Displacement History Between Landing and Stairs Showing Permanent Deformation (MCE; Fixed-Free)

in. of relative displacement at the top landing for the hanging or sliding systems.

The fixed-free configuration performed satisfactorily for smaller amplitude DBE motions with no live load but yielded the top connection plate during the MCE motion. The landing was subsequently strengthened to test the assembly with the full 100 psf live load. Even after measures were taken to strengthen the upper landing connection the weld between the top plate and the landing fractured in the MCE motion. This configuration had the largest relative deformation between the stairs and the landing at nearly 8 in. compared to less than 5 in. for the hanging-fixed case.
