Dynamic characteristics and seismic behavior of prefabricated steel stairs in a full-scale five-story building shake table test program

Xiang Wang¹, Rodrigo Astroza^{1,2}, Tara C. Hutchinson^{1,*},†, Joel P. Conte¹ and José I. Restrepo¹

SUMMARY

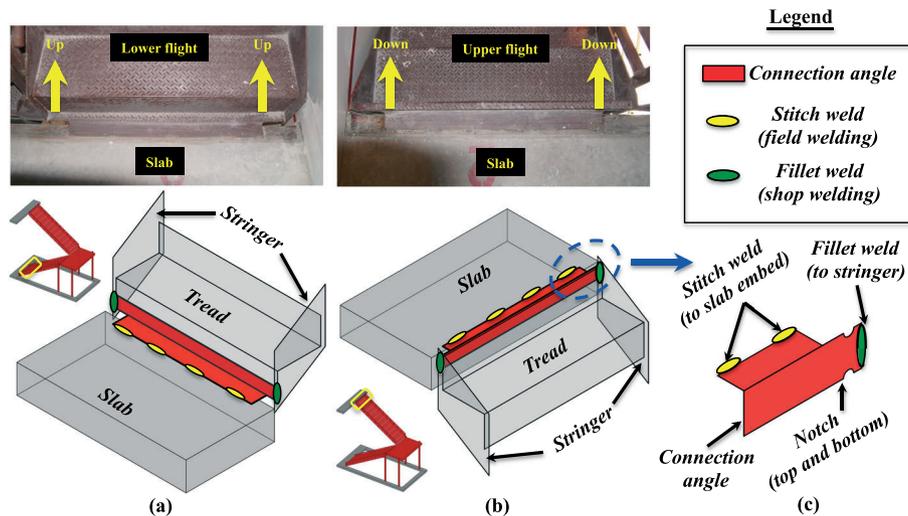
Figure 4. Flight-to-building connection details: (a) lower flight to slab connection, (b) upper flight to slab connection, and (c) upper flight connection angle.

3.1.2. Flight-to-building connections. With the exception of the lower flight at level 1, which was connected to the slab at the first floor (foundation) using post-installed wedge anchors, the lower flights at level 2 through level 5 were each connected to the building using an ASTM A36 $L102 \times 76 \times 6.4$ mm angle (Figure 4(a)). Likewise, the upper flights at all levels were each connected to the building using an ASTM A36 $L76 \times 51 \times 6.4$ mm angle (Figure 4(b)). All these connection angles were shop welded to the stair stringers at each end and field welded to the steel embed cast with the building using 51 mm long stitch welds spaced at 305 mm on center. **It is noteworthy that while the lower flight to building connections were designed to provide limited deformability, the upper flight connection angles differed from those at the lower flight because of the presence of a pair of notches at the ends of the vertical legs of the connection angles (Figure 4(c)). These notches were intended to facilitate floor-to-floor relative motions and intended to yield during design interstory drift demands.**

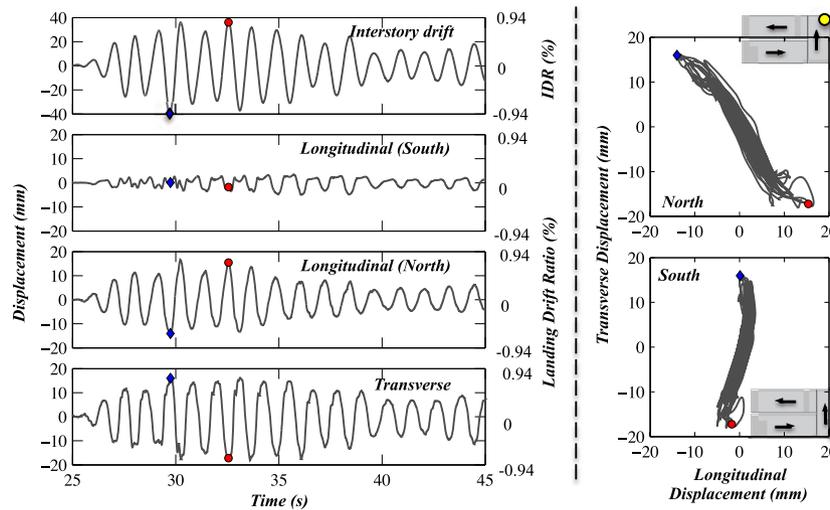
As shown in Figure 14, the longitudinal landing displacements at the two corners differed significantly. While the peak relative displacement was 17 mm (corresponding to a landing drift ratio of 0.8% or a peak interstory drift of 41%) on the north corner, the response was much smaller at the south corner of the landing and the peaks did not coincide with those of the interstory drift response. The fact that the transverse displacement of the landing was as large as the longitudinal counterpart at the north corner indicates that the stair landing twisted appreciably. Figure 14 also presents the orbital plots of

Figure 14. Displacement time histories of the stair landing at level 2 relative to the lower floor during test FB-3 (note: red dot denotes the positive interstory drift peak and blue dot denotes the negative peak).

the displacement responses at the two corners of the landing. Correlation of the stair displacement responses in the two horizontal directions of the building further corroborates the landing torsional response. It is clearly shown in the orbital plots that while the relative displacement was primarily in the transverse direction at the south corner, the north corner of the landing moved diagonally as the amplitudes of the relative displacements were similar in the two orthogonal directions. This can be attributed to the fact that the upper flight-to-building connection was much more deformable than the lower flight-to-building connection, and therefore allowed the landing to move in a torsional mode against the landing-to-lower flight connection.

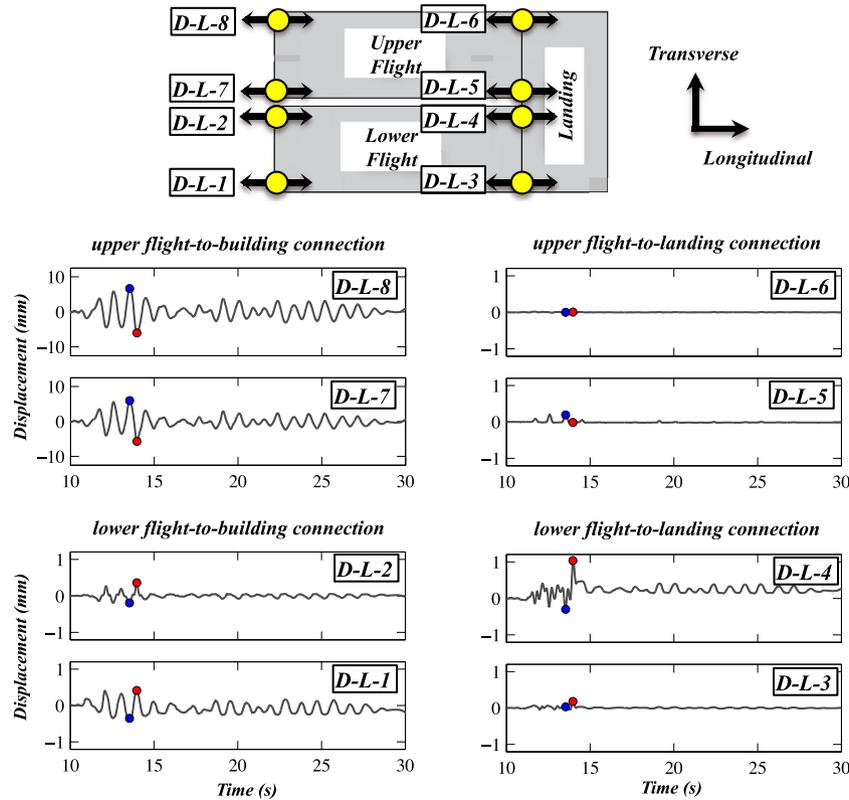
Figure 15. Longitudinal connection deformation time histories of the stair at level 2 during test FB-3 (note: red dot denotes the positive interstory drift peak and blue dot denotes the negative peak).

flight-to-building connection was about 16 mm (about 30% of the peak interstory drift at level 2) and were much larger than that of the lower flight-to-building connection. It is noted, however, that D-L-1 failed to record the connection deformation shortly after the negative peak interstory drift occurred. In addition, comparison of the connection deformation responses to the peak interstory drifts suggests that the two flight-to-building connection deformation responses were in the complete reversed direction. The flight-to-landing connection deformations were also small compared with those of the upper flight-to-building connection. It is noteworthy that the repair action R-II (Figure 10(b)) of the upper flight-to-slab connection for the stair at level 2 immediately following test FB-4 modified the original deformation mechanism of the stair system. Absent the intended yielding mechanism at the upper flight-to-building connection because of the repair, the relative deformation of the other connections increased significantly during the last two FB tests and led to plastic yielding of the connection plate between the lower flight and the landing during test FB-5 (Figure 9(d)).
